# Advanced Failure Analysis of Hydraulic Systems in Volvo Articulated Haulers at Coal Mining Sites: Investigating Steering Cylinder Seal Failure and Brake Accumulator Degradation

**Keywords:** Volvo Articulated Hauler; Steering Cylinder Seal; Brake Accumulator; Coal Mining Maintenance.

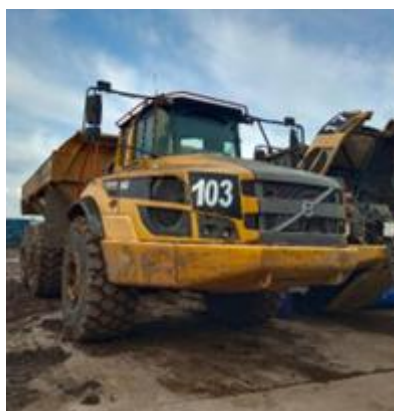
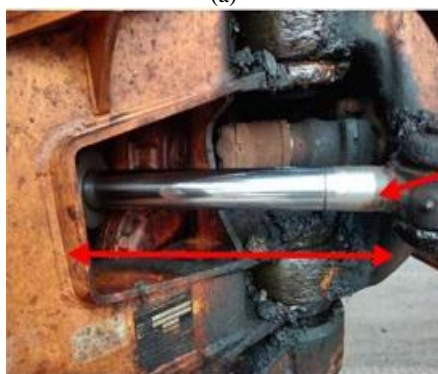
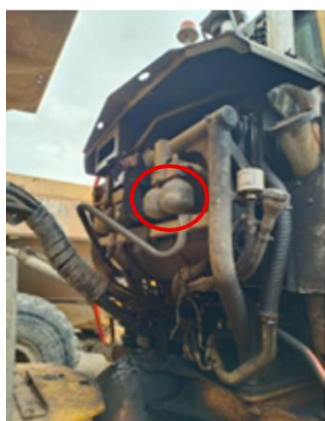
This study investigated two articulated hauler units operating a Volvo ART A40F (SN 11001-99999) with a hydraulic steering system operating at a maximum pressure of 250 bar ( $25.0 \pm 0.4$  MPa) [23], and a Volvo ART A40G equipped with an electronically controlled braking system and seven hydraulic accumulators [14], as shown in Figure 1

**Figure 1.** Volvo Articulated Hauler a). A40F (SN 11001-99999), b). Steering Cylinder Seal, c). Brake Accumulator

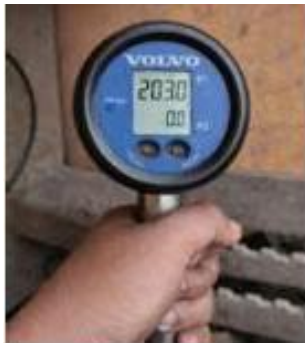
The investigation of the Volvo ART A40F steering system began after operators reported that the steering had become heavy and less responsive over several operating shifts. Visual inspection identified active hydraulic oil leakage from the left steering cylinder, indicated by oil contamination around the cylinder body, articulation frame area, and oil accumulation beneath the unit. Pressure testing showed that the steering system operated at only 203 bar at full steering lock and 1200 rpm, which was below the Volvo standard specification of  $250 \pm 4$  bar [23], pressure drop can be shown in the Figure 2. This condition indicated a pressure reduction of approximately 19% from the normal operating value.

**Figure 2.** Hydraulic Pressure Measurement in Steering System

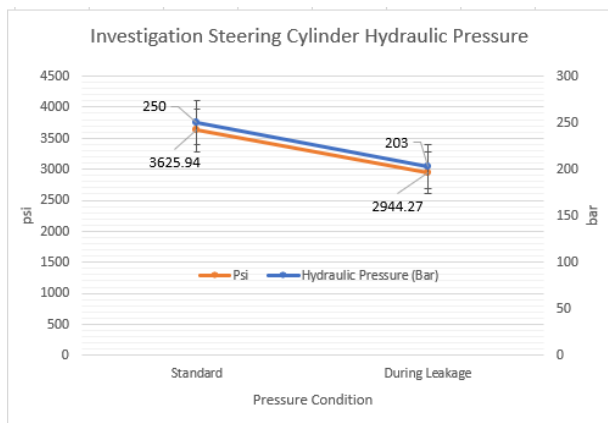
Based on the analysis of the standard specification data on the Volvo A40F, there is a significant decrease in pressure, the normal standard shown in the Table 1 and the results of the measurement analysis are explained in the following Figure 3.

**Figure 3.** Investigation Steering Cylinder Hydraulic Pressure

Investigation based on pressure testing showed that the steering system operated at only 203 bar at full steering lock and 1200 rpm, which was below the Volvo standard specification of  $250 \pm 4$  bar and In addition, the hydraulic oil level in the reservoir was measured at around 203 liters compared to the standard capacity of 245 liters. investigation based on Standard Specification Volvo A40F SN 11001-99999, shows the need for component improvements based on research data on scraper / seal dust which has experienced a reduction in dimensions from standard size of 7.8 mm. Scraper / seal dust repair is shown in the Figure 7, and the comparative measurement results are shown in the graphic Figure 8.

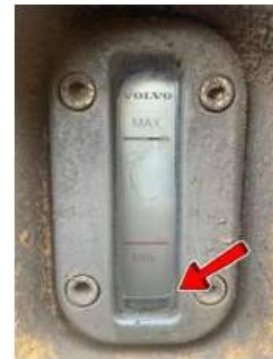
In addition, the hydraulic oil level in the reservoir was measured at around 203 liters compared to the standard capacity of 245 liters, confirming a loss of about 42 liters of hydraulic fluid caused by the seal leakage as shown in the Figure 4.

**Figure 4.** Hydraulic Oil Level

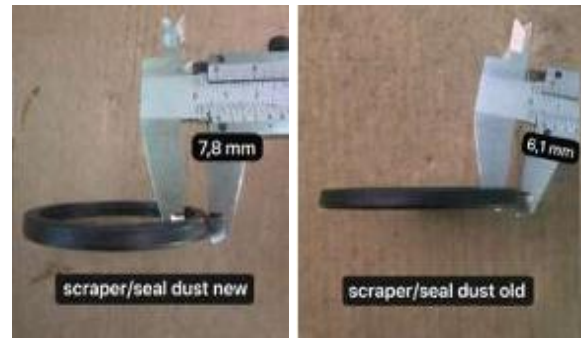
The most significant finding was observed on the scraper component. Measurement showed that the scraper thickness had decreased from 7.8 mm to 6.1 mm, representing a 22% reduction in material, shown in the Figure 6. Since the scraper functions

to remove dust and particles from the piston rod surface before entering the cylinder, this reduction weakened its sealing effectiveness and allowed fine contaminants from the mining environment to enter the seal area, accelerating wear and leakage [18], [25].

**Figure 6.** Comparison Scraper/Seal Dust, a). New, b). Old

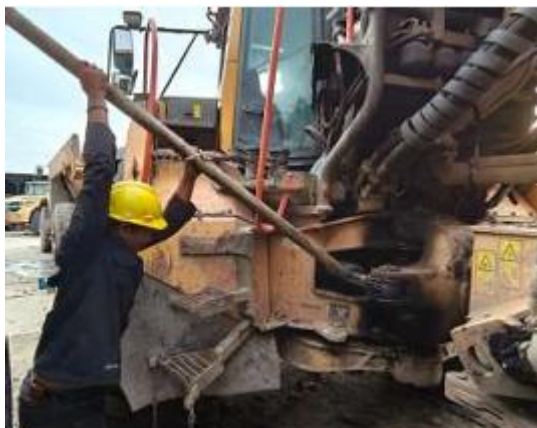
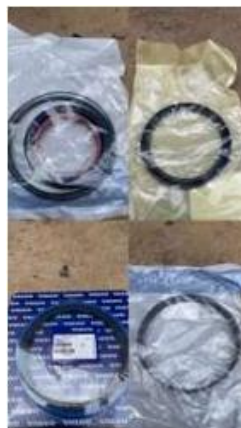
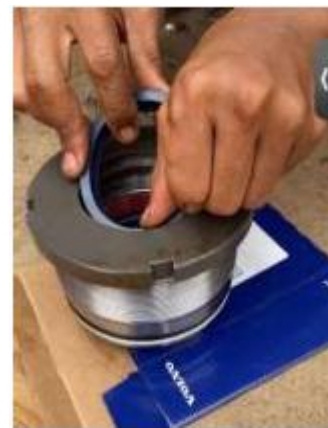
**Figure 7.** Repair Volvo Articulated Hauler a). Piston Rod Guide, b). Scraper/Seal Dust, c). Installation

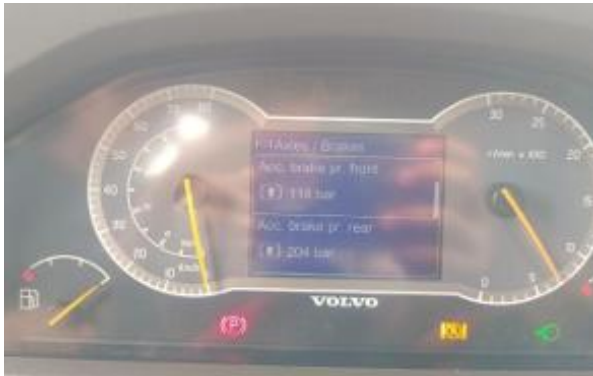
Investigation in the Brake Accumulator Degradation on the Volvo Articulated Hauler (ART) type A40G, the occurrence of failure on the Volvo ART A40G was detected after investigation red low-pressure warning alarm accompanied by automatic parking brake activation. Monitor data showed that the front accumulator pressure had dropped to 118 bar, below both the warning limit of 145 bar and the automatic parking brake threshold of 140 bar [14], shown in Table 3 and Figure 11. As a result, the unit could not be operated and required immediate maintenance intervention. Initial inspections of the hydraulic pump, control valves, solenoids, and hydraulic lines showed no signs of leakage or malfunction. After these components were ruled out, the investigation identified the accumulator bank as the main cause of the pressure loss. This troubleshooting sequence follows standard hydraulic brake diagnostic procedures commonly applied in heavy equipment maintenance [27].

**Figure 11.** Actual Measurement Results on Monitor Unit
